**DRAFT FINAL PARCEL B SITE INSPECTION REPORT, PUBLIC SUMMARY,  
VOLUME 1 OF 2**

**Public Summary  
Draft Final  
Parcel E Site Inspection Report  
Naval Station Treasure Island  
Hunters Point Annex  
San Francisco, California**

April 18, 1994

**PUBLIC SUMMARY  
DRAFT FINAL PARCEL B SITE INSPECTION REPORT  
HUNTERS POINT ANNEX  
SAN FRANCISCO, CALIFORNIA**

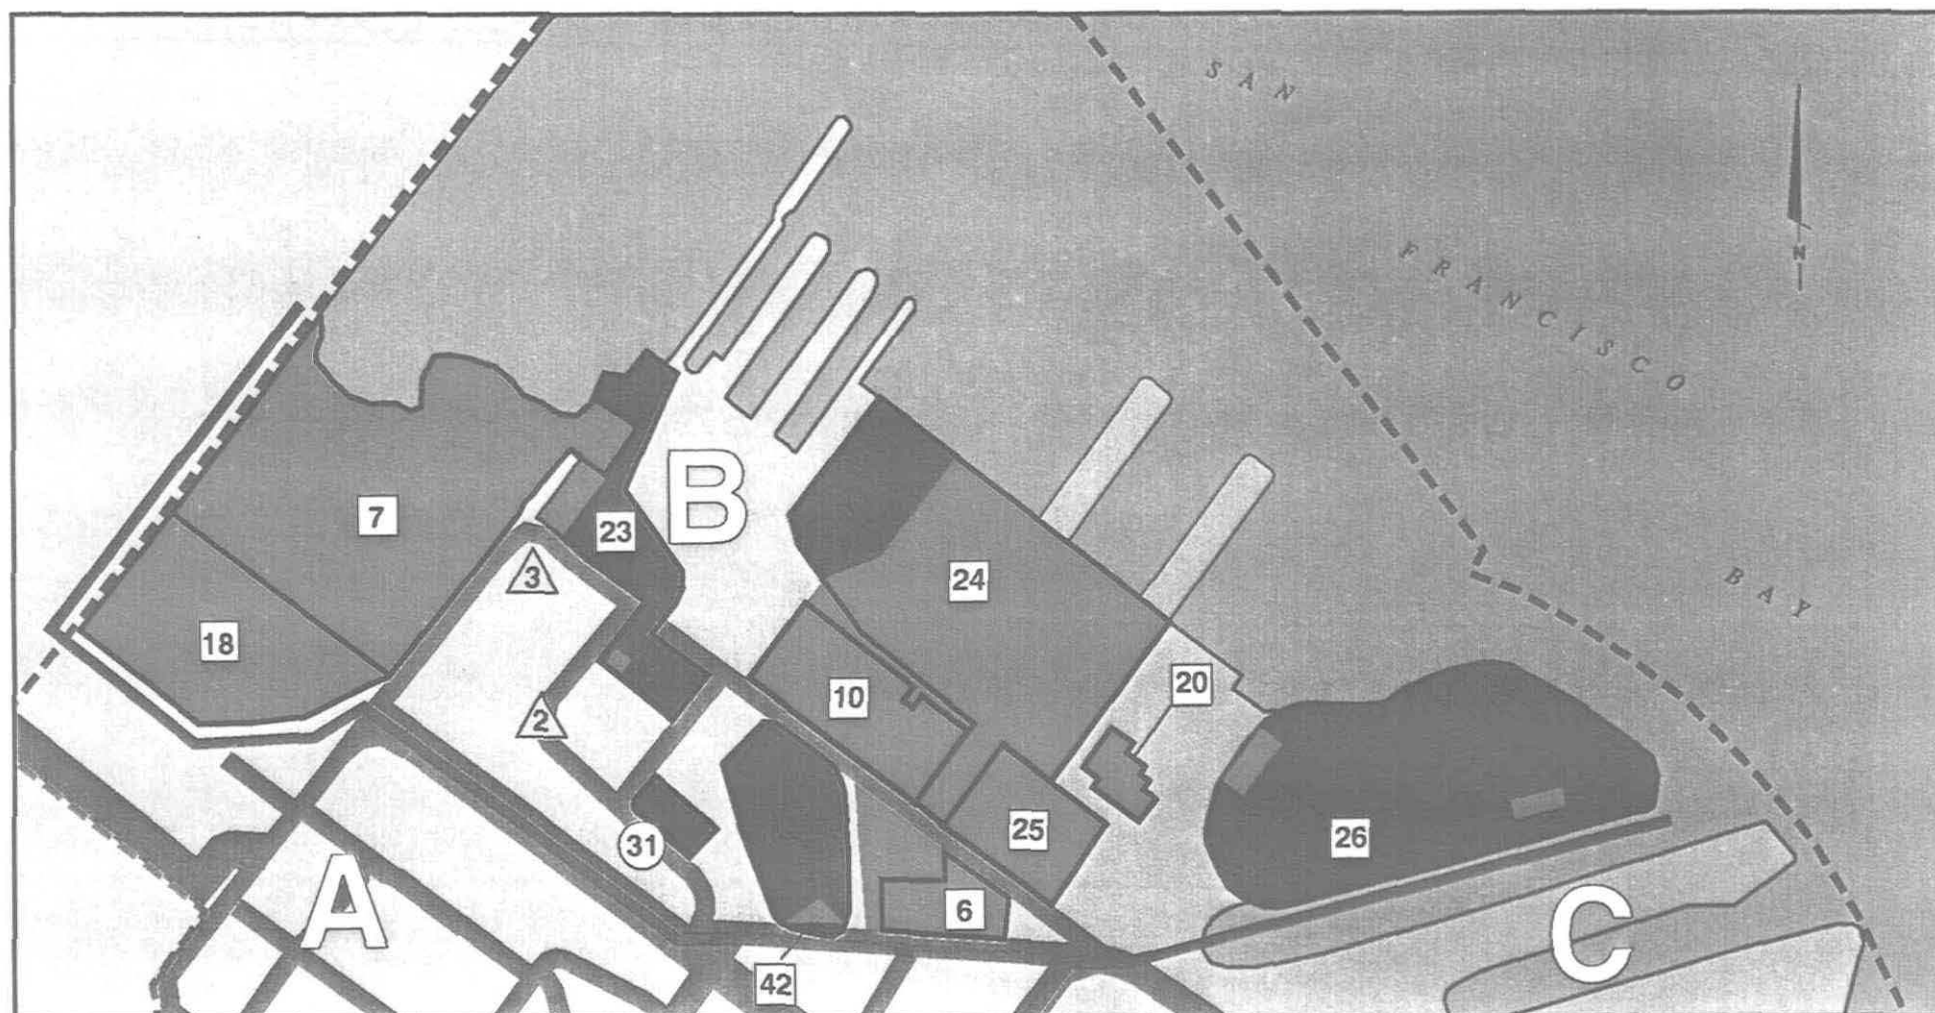
Figure 3. Parcel B Site Inspection Results

No further action is recommended for areas shown in dark blue on Figure 3; areas shown in red are or will become IR sites. Additional reports on the IR sites are available in the administrative record at local information repositories.
